Manhole Inspection Summary

Manhole # **S31E__018MH**

Insp Date: **3/28/08 2:28 PM**

Location Address: **224 GREENE ST** Cross Street: **SARATOGA ST**

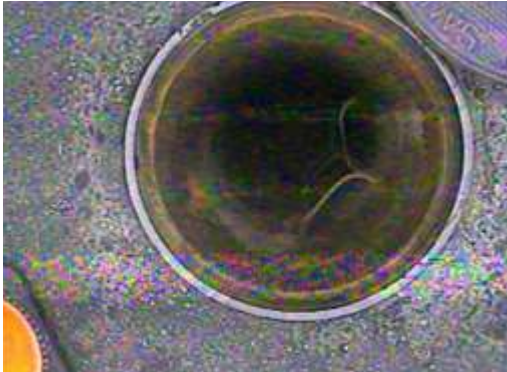
Top View

Frame Offset: **1** (in.) Condition: ☒ Sound ☐ Cracked ☐ Leaks

FRAME OFFSET

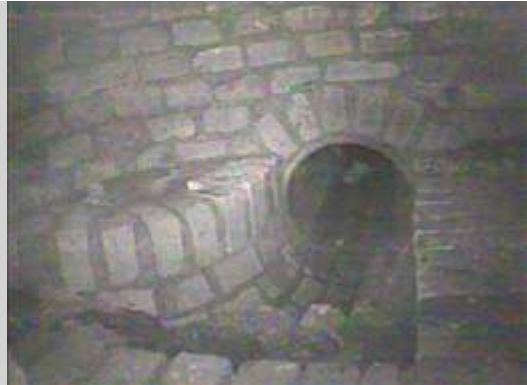
12 O'Clock Outflow

8 in. Circular Gravity Sewer
Pipe Out @ 12 O'Clock

Pipe Height: (in.) Direct
Pipe Material: **Clay** ☐ Pipe Lined
Invert Depth: **10.70** (ft.) Flow Characteristics: **Slow**
Deposits: ☐ None ☐ Mud ☐ Gravy ☒ Debris ☐ Grease
Silt Depth: **0** (in.) Deposits Extent: **Light**
Infiltration: **None** Pipe Seal Cond: **Sound**

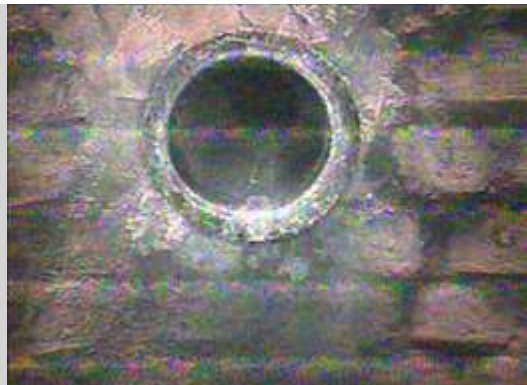
7 O'Clock Inflow

6 in. Circular Gravity Sewer
Pipe In @ 7 O'Clock

Pipe Height: (in.) Direct
Pipe Material: **Clay** ☐ Pipe Lined
Invert Depth: **8.93** (ft.) Flow Characteristics: **None**
Deposits: ☒ None ☐ Mud ☐ Gravy ☐ Debris ☐ Grease
Silt Depth: (in.) Deposits Extent:
Infiltration: **None** Pipe Seal Cond: **Sound**

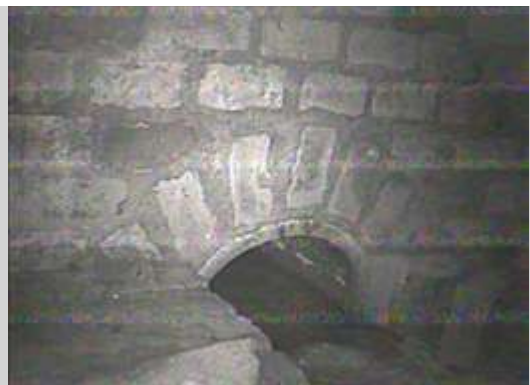
9 O'Clock Inflow

8 in. Circular Gravity Sewer

Pipe In @ 9 O'Clock

Deposits: ☐ None ☐ Mud ☒ **Sludge** ☐ Debris ☐ Grease

Silt Depth: **3** (in.) Deposits Extent: **Light**
